Phenomenon of Penetration of Vertical Pipes into the Horizontal Members of Concrete Structure

Abstract: The typical types of the Riyadh's houses are limited in villas, duplexes and low-rise apartment buildings. Most of these dwelling houses are constructed using reinforced concrete framed structures with reinforced concrete flat roof deck slabs, ribbed slabs, joist floor slab (Hordy). Unfortunately, there are some construction problems that occurred due to wrong practice by the contractors. One of these problems is what we can call "phenomenon of penetration of vertical pipes into the horizontal members such as beams and slabs of concrete structure". This phenomenon practiced in some dwelling houses deserves consideration regarding its possible serious impact on the structure. The seriousness of this phenomenon lies in its hidden influence, which might happen suddenly or gradually, partially or totally in the form of cracking or collapsing. If this practice continues without evaluation, it may cause damage and severe failure in the structure. This paper emphasizes the serious effect of this practice by using a computer simulation program, which indicate that the severe cracking in

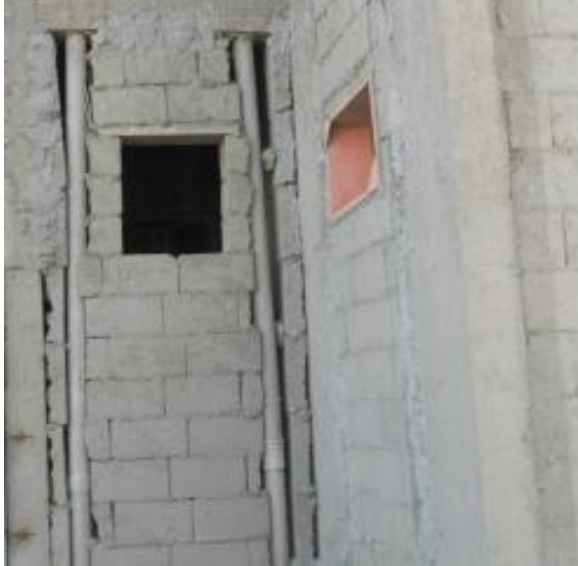
Figure 1. Sanitary pipes passing across the depth of the beam and across the wall's height

This construction movement faces some improper practices, one of these is installing vertical sanitary pipe (of $3'' = 76.2 \text{ mm}$) through structure members (Figures 1, 2, 3, 4). The purpose of doing that from the plumbing contractor's point of view is to provide an easy way to hide the sanitary pipes and to make sure that the facade of the building is not disturbed by these pipes. However, the sound practice would be to provide small vertical ducts through the slabs, within the sanitary facilities rooms or on the facade, to enclose the pipework and so avoiding damage to the beams.

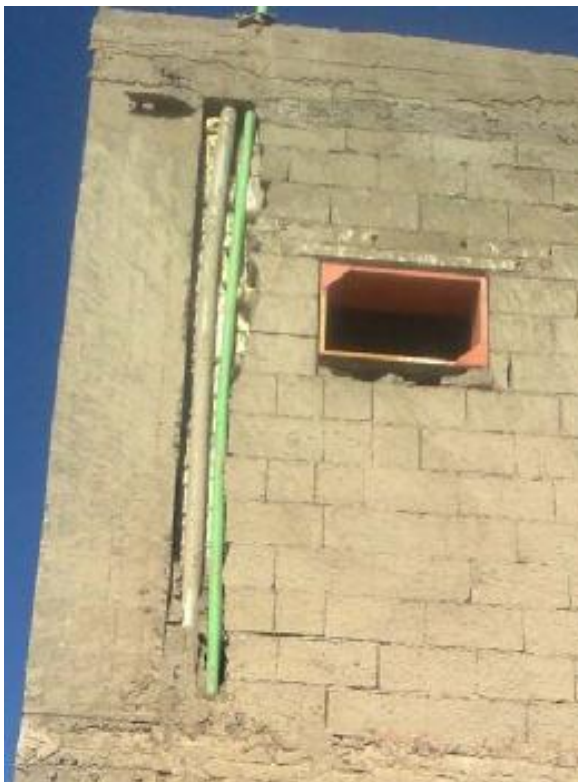
Figure 2. Two services (Sewage and water pipes) introduced at end of the beam and column's interior face breaking the wall's bond with the column.

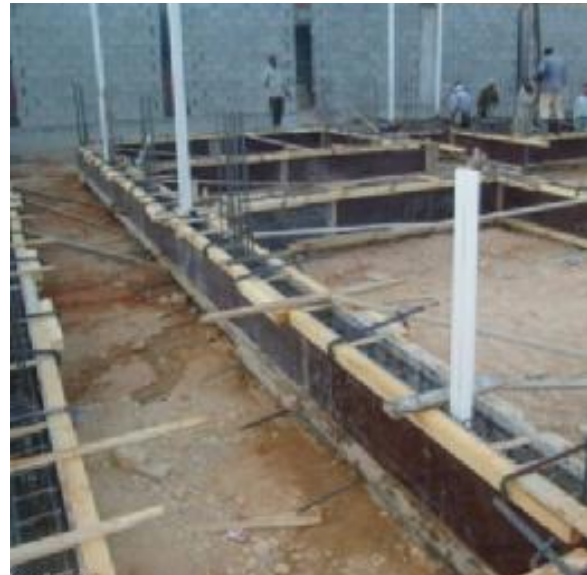
Figure 3. Introduction of pipes at several points across the depth of ground beams.

Figure 3, shows the introduction of sanitary pipe in three different points located in span 1, span 2 and span 3 of the beam running in the center across the depth of the main beams.

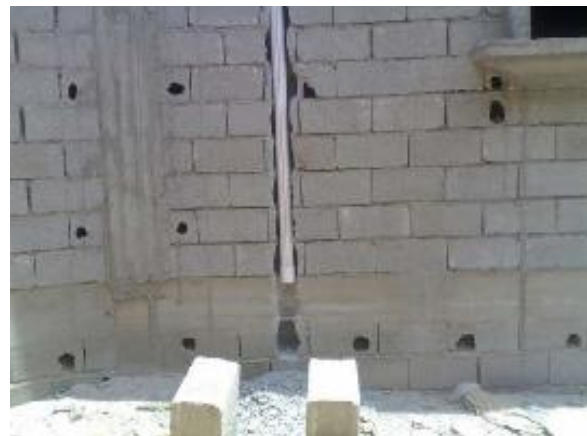
Figure 4. Beams showing the exposure of the reinforcement due to introduction of pipes across the depth of the beam.

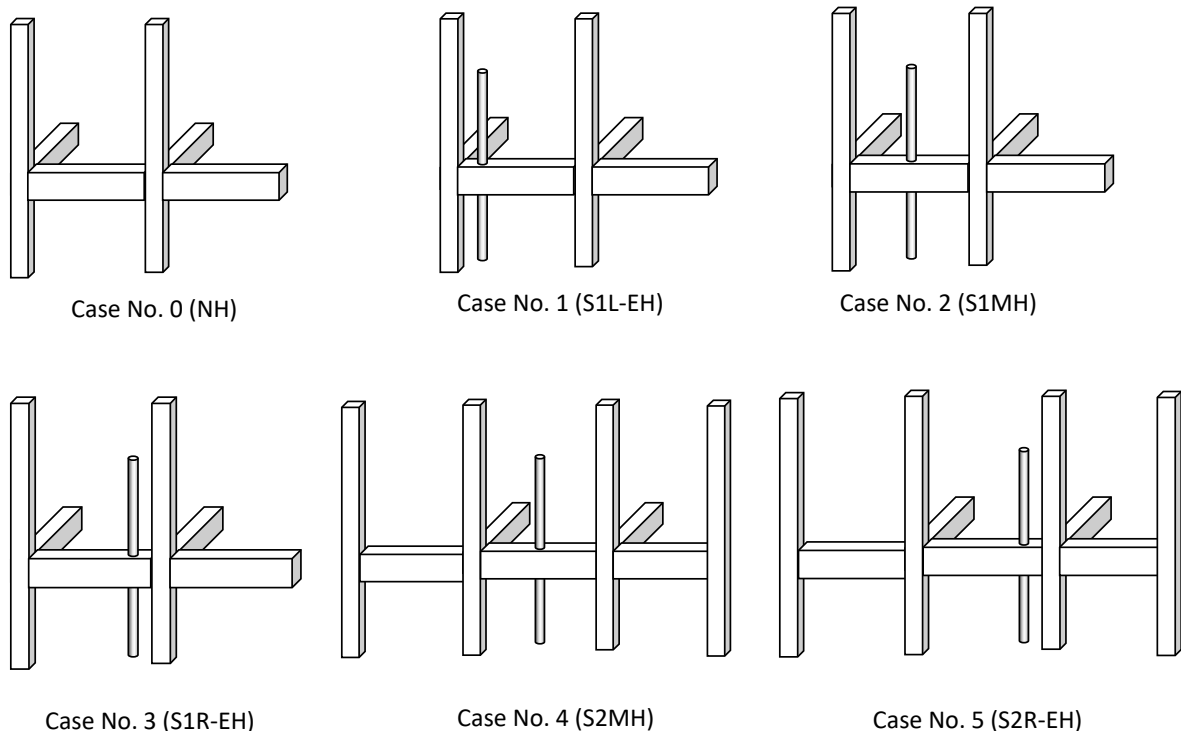
Figure 5. Shows the parts of the building's beam framing through which a service pipes may pass vertically, at different locations.

- No hole is located in the beams. (NH)
- Hole is located close to the exterior edge of the end beam. (S1L-EH)
- Hole is located in the center of the end beam. (S1MH)
- Hole is located close to the interior edge of the end beam. (S1R-EH)
- Hole is located in the center of the middle beam. (S2MH)
- Hole is located close to the right edge of the middle beam. (S2R-EH)

The introduction of a hole (for different cases as shown in figure 5) may cause a local crushing of concrete and a plastic hinge is assumed to develop, and the beam moments are readjusted due to this phenomenon [a thesis, by Zeynep, 2010]. This is due to the insufficient cross-section of the concrete beam.

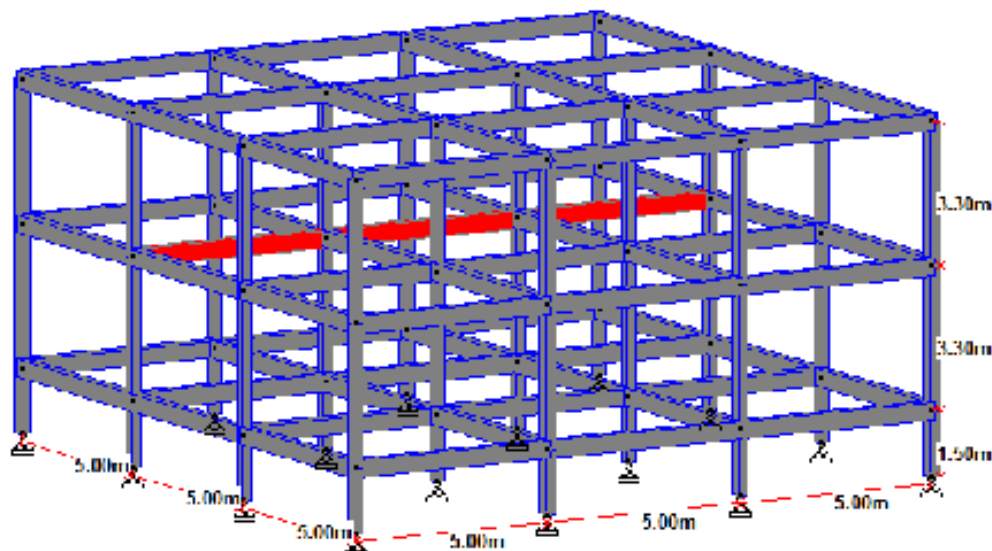
Figure 6. The Framing model used in STAAD Pro of the building normally used for a residential building in Riyadh region.

The frame work is shown which is developed in the STAAD Pro model. The beam cross section dimensions have been chosen to reflect the normal trend of the design offices for the residential buildings in Riyadh area as 250mm x 400mm to accommodate the walls of 250mm. This width does not increase generally more than 250mm due to architectural restriction. And the column dimensions adopted as 250mm x 250mm which is a common local practice. Normally a Compression Strength of concrete f_c' is used as 30 N/mm².

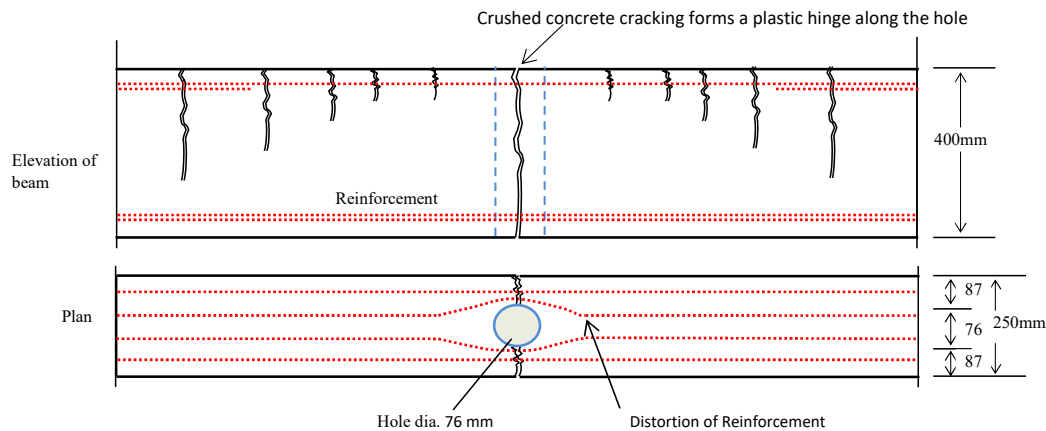
Figure 7. Showing the failure mechanism at hole point forming a plastic hinge in a beam.

introduced horizontally in the web). It is because the hole size would reduce the width from 250mm to 174mm by the introduction of 3" (76 mm) hole which is 30.5% of the effective width in the tension and compression zones. This generates a plastic hinge at the hole point as shown in Figure 7.

cross-section (unlike when a hole is introduced horizontally in the web). It is because the hole size would reduce the width from 250mm to 174mm by the introduction of 3" hole, which is 30.5% of effective width in the tension and compression zones. Also, this does not allow the horizontal bending moment bars for proper spacing arrangement maintaining the requirements of ACI code for the bar spacing. Also, the stirrups arrangement and spacing is distorted and disturbed as shown in Figure 7.

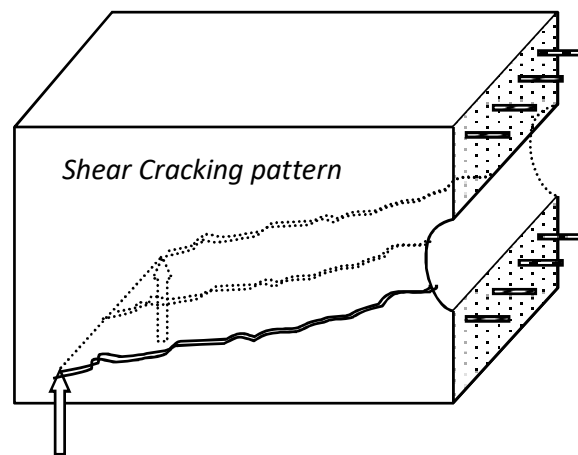
Figure 8. Horizontal web hole effective in Shear Crack.

The previous research work reveals that almost all the research work has been done on the introduction of web holes (Transvers holes) as shown in Figure 8. The results of the previous research has shown in all the cases (as mentioned in the literature review) that the beams have cracked at the web holes. Other studies for the web hole research has shown atleast a maximum reduction of beam capacities upto 35 % for simple beams [Ashraf 2014].

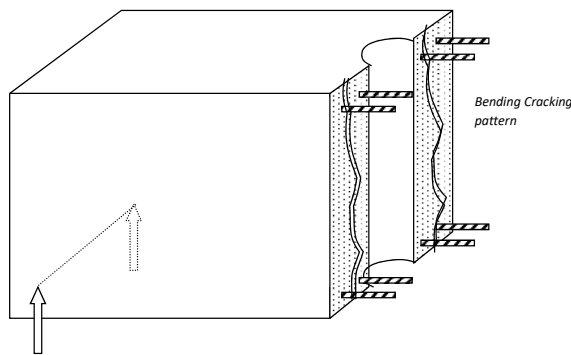
Figure 9. Vertical hole effective in bending cracks.

The current study has been made for the introduction of vertical holes as shown in Figure 9, which effects more seriously the capacity of the beams by cracking due to shear and bending. The cracking is expected 100% because of the reduction in the tension and compression zones of the beam's

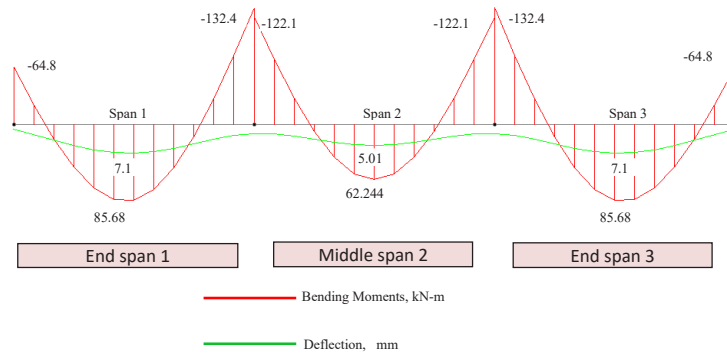
Figure 10. Distribution of bending moments and deflections in span for CASE 0: (No Holes)

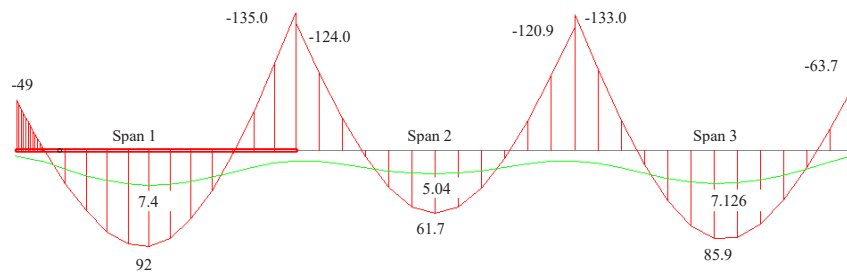
Figure 11. Bending moments and deflections in span for CASE 1: (Hole in the Left End of Span 1)

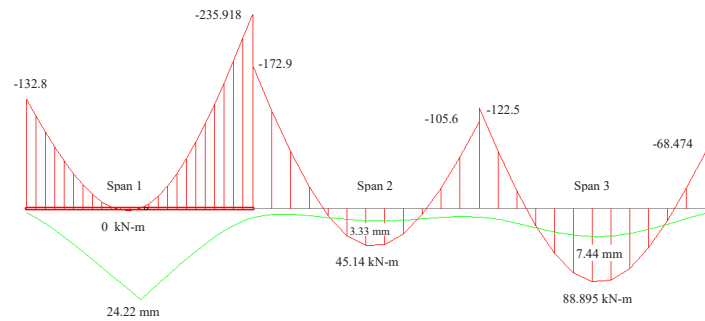
Figure 12. Bending moments and deflections in span for CASE 1: (Hole in the Left End of Span 1)

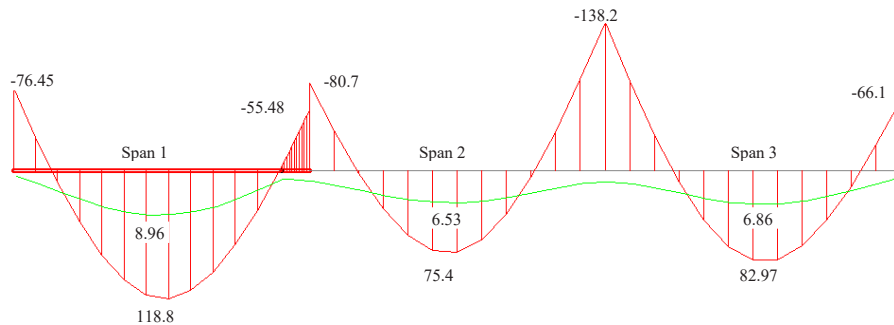
Figure 13. Bending moments and deflections in span for CASE 3: (Hole in Right End of Span 1)

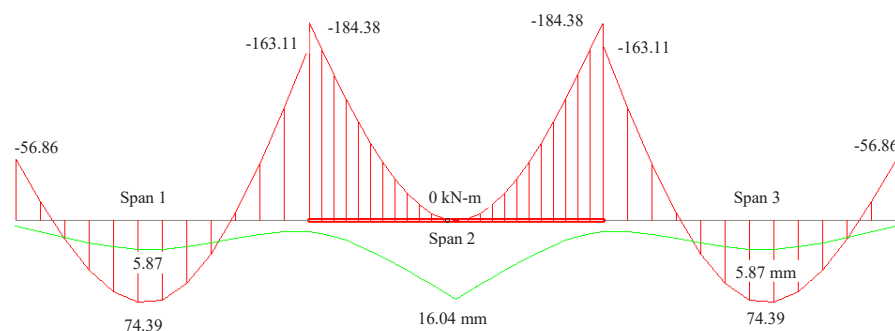
Figure 14. Bending moments and deflections in span for CASE 4 (Hole in the Middle of Span 2)

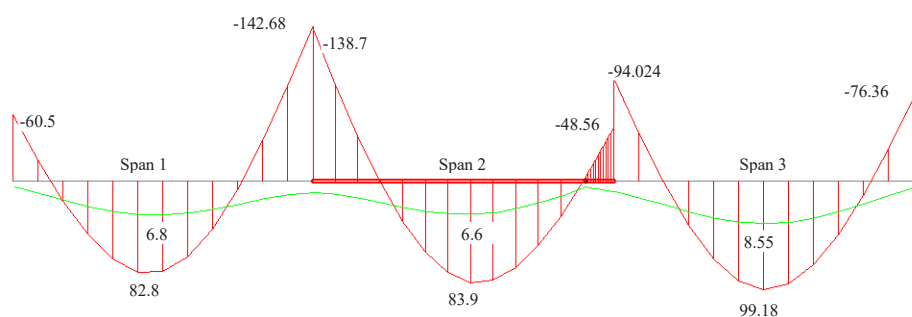
Figure 15. Bending moments and deflections in span for CASE 5: (Hole in the Right end of Span 2)

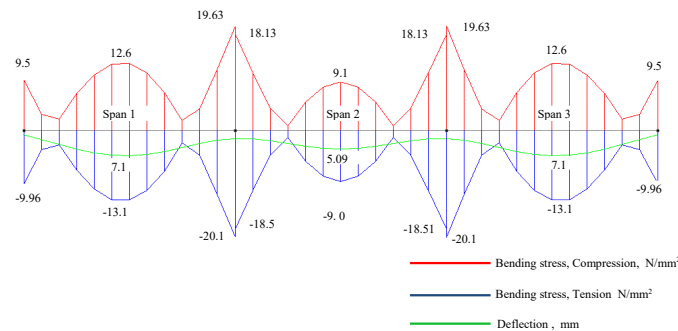
Figure 16. Case 0: Deflection profile and maximum bending stresses in the three spans when there is no hole

The maximum beam stresses are found to be 20.1 N/mm² (Figure 16), which is less than the compression strength of concrete used and safer to carry the stresses introduced in the concrete without any holes.

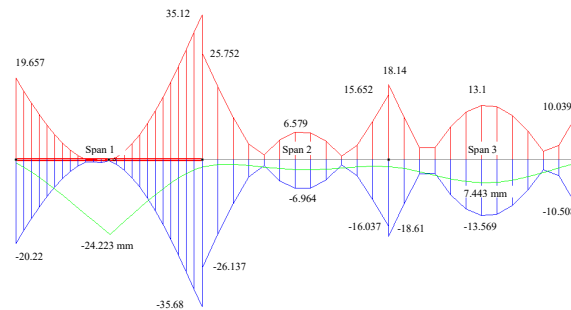
Figure 17. Case 2: Deflection profile and re-adjusted maximum combined axial and bending stresses (Compression and Tension) in the three spans due to the hole inserted in middle of span-1

Maximum beam stresses are found to be 35.68 N/mm² (Figure 17), which is more than the compression strength of concrete used. Concrete is failing in compression in case-2 due to introduction of vertical hole in the middle of the span-1. This case is very critical and with severe effects when compared to all other cases. The maximum beam stresses are found to be 27.87 N/mm² (Figure 18), which is less than the compression strength of concrete used and safer to carry the stresses.

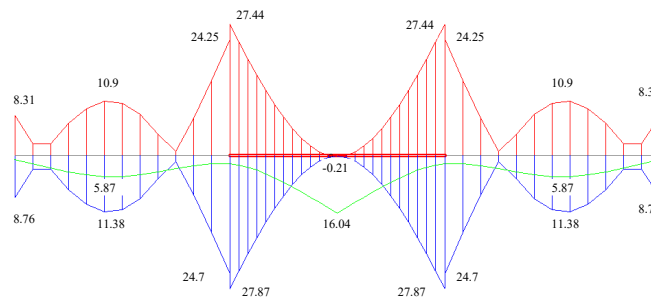
Figure 18. Case 4: Deflection profile and re-adjusted maximum combine axial and bending stresses (Compression and Tension) in the three spans when the hole in middle of span 2.
